1 Summary

The XIS0 suddenly showed an anomaly on June 23, 2:00 UT. During a Normal clocking operation, a part of the segment A of the XIS0 was flooded with a large amount of charges, which caused saturation of the analogue electronics. The anomaly was very similar to that occurred in the XIS2 in 2007. We suspect that both anomalies have the same origin, possibly a micro-meteorite impact. In the Normal clocking mode, the effect is almost localized to a 1/8 area of the XIS0. The XIS team continues to operate the XIS0 in this mode. Users need to be aware of several remaining artifacts after the event. In the Psum clocking mode, the effect spreads to the entire XIS0 with severe degradation of the data. The XIS team discontinues the use of Psum clocking mode for the XIS0.

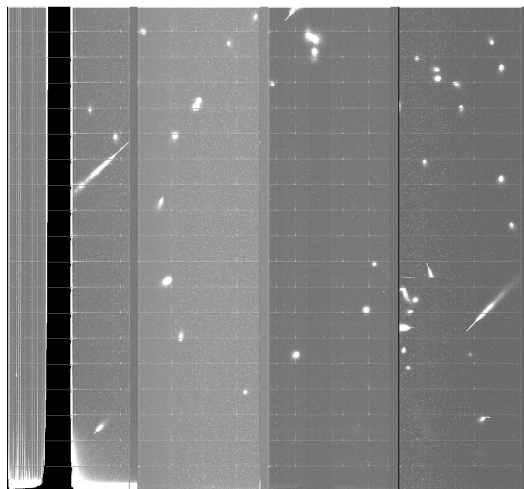
Figure 1 shows an example of the frame mode data obtained from XIS0 after the anomaly. Phenomenologically, the anomaly was caused by the leakage of charges somewhere in the imaging area of the segment A. About a quarter of the segment A was flooded with a large amount of leaked charges, which was so large that the analogue electronics was saturated and no event was recorded.

Although the cause of the anomaly is yet to be identified, all the phenomena are very similar to those occurred in the XIS2 in 2007 (Suzaku memo 2007-08). We suspect that both anomalies were caused by an impact of micro-meteorite. The probability of micro-meteorite impacts is non-negligible for instruments equipped with X-ray telescopes with a large effective area. For XIS, two impacts in four years is not beyond the statistical expectation.

Figure 1: XIS0 frame data image taken at 19:59 UT on June 23, 2009. Segments A to D from left to right in the ACTXY coordinate.

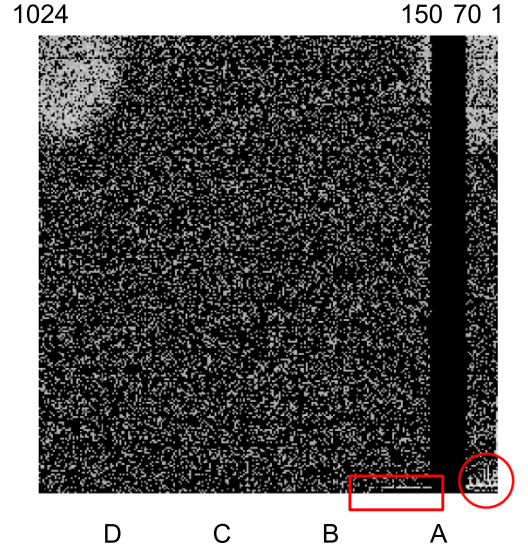
Figure 2 shows a non X-ray background image constructed from the data during the night-earth occultation. Two artifacts are apparent:

- All events in the damaged part (DETX=70–150) in the segment A are discarded onboard. This part appears blank in post-event images from June 27, 2009 onward.
- In some data, artificial signals frequently appear close to the bottom end of the segment A (red regions in figure 2).

Figure 2: XIS0 image of non X-ray background constructed from observations during night-earth occultation in the DETXY coordinate with segments A to D from left to right. Regions with frequent artificial signals are shown with red shapes.

In the Normal clocking mode without window/burst options, the damage to the sensor is limited to a part of the segment A and is stable since the occurrence of the anomaly. The damaged part is at the fringe of the imager, causing little loss of photons for normal observations. The XIS team decided to continue the XIS0 operation in the Normal clocking mode without burst/window options.

All science data taken after the anomaly are subject to these artifacts. Users need to pay attention to these when reducing and interpreting their data.

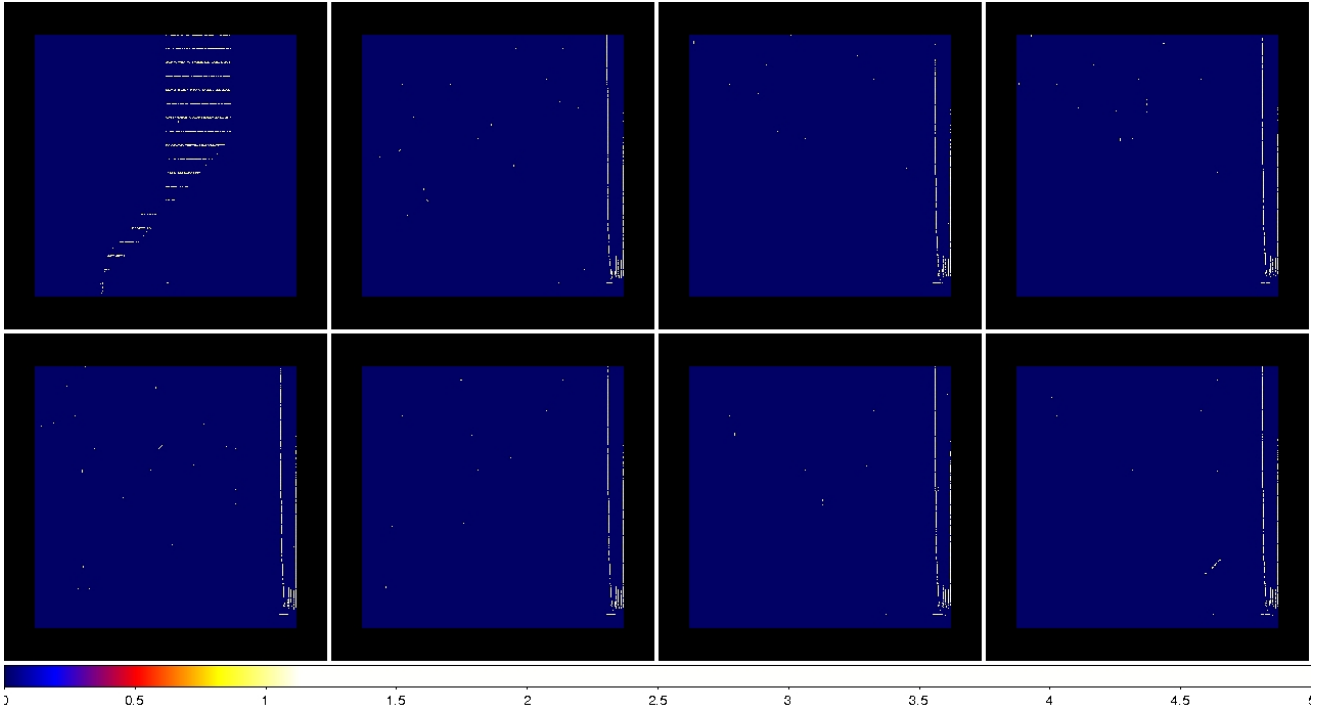
Figure 3: First eight frame images of the XIS0 in the Normal clocking mode with a 0.1 s burst option in the DETXY coordinate.

The XIS team took frame data of the Normal clocking mode for all the officially supported combination of burst and window options, spending a month after the anomaly. Some frames show leaked charges outside of the damaged part of the segment A. Figure 3 shows the first eight frames taken in the frame data acquisition operation with the 0.1 s burst option on July 30, 2009.

The XIS team considers that the effect by the additional artifact outside the damaged area is minimal, taking account of the fact that the use of burst/window options is limited to bright point-like sources observed in the segments B and C. The team thus decided to continue the XIS0 operation in the Normal clocking mode with burst/window options as before the accident.

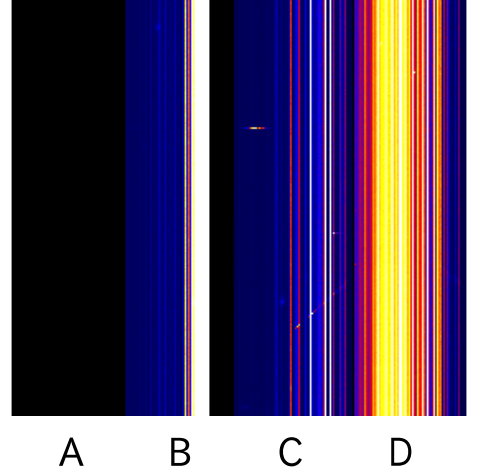
On the contrary to the Normal clocking mode, the Psum clocking mode is severely affected by the accident. Figure 4 shows a frame data of the XIS0 taken on October 10, 2009. The pixel level is 0 in the entire segment A. Moreover, many columns in the segment B and the entire segment D show a very high pixel level. The spectra taken in the segment B and C are distorted in comparison to those taken in the XIS3.

Figure 4: Frame image of the XIS0 in the Psum clocking mode in the ACTXY coordinate.

Because the effect spreads to the entire XIS0 chip and the data are severely degraded, the XIS team decided to terminate the XIS0 operation in the Psum clocking operation mode. All XIS0 data taken in the Psum clocking mode after the incident are not suitable for any scientific purposes.

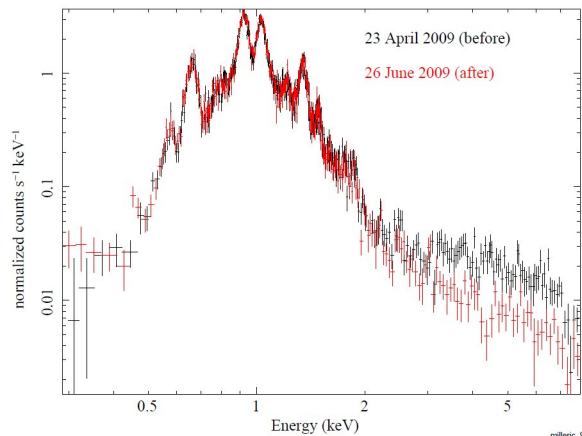
We are currently investigating the possible change of the XIS0 detector response before and after the anomaly. A small discontinuous change (a few eV at 5.9 keV) in the gain history was observed in the segments A and D, whereas no measurable change was found in the energy resolution for all the segments. The gain shift will be compensated in the upcoming version of the response generator. Overall, the XIS team considers that the change of the response due to the anomaly is minor if any. A comparison of the E0102-72 spectrum is shown in figure 5, where no significant change was found before and after the anomaly below 2 keV, where the emission is dominated by this source.

Figure 5: Comparison of E0102-72 spectrum before (black) and after (red) the anomaly. The difference above 2 keV is due to the variation in a contaminating HMXB and is irrelevant to the anomaly.
